I. Introduction:

This report has been created to provide information about the allotment boundary for the Town Council, aiming to assist in the council's decision-making process regarding the allocation and administration of allotment plots. This comprehensive report examines the conditions of fences, gates, hedges, trees, and litter within the allotment boundary, offering a detailed overview of their current state.

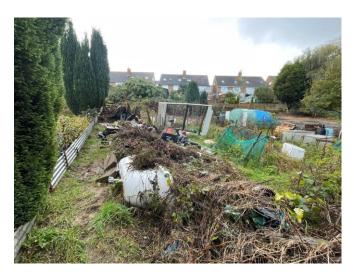
Fly-tipping has become a huge problem due to fencing not being tall enough for the public and fellow plot holders.

Fly tipping removal had started 7A Plot fly tipping clearance, one van load taken, a few more needed.
