#### I.I Introduction

This report aims to address the current condition of Preston Road, Norfolk Close, Sidley, TN39 5BT Allotment fencing, highlighting compromised areas that require immediate attention. It includes a detailed analysis of each compromised fencing segment, supported by corresponding photographs. Additionally, this report provides suggestions for repair or replacement, ensuring the safety and security of our Allotment Plot Holders.

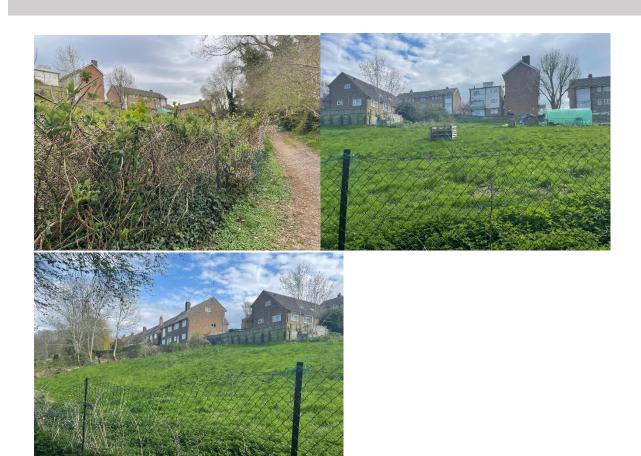
**Location:** Top Half of Allotment

**Description:** There is part Wooden fencing and Chain fencing. It is 2 meters in height. The Condition currently is that they are worn and not tall enough, dented in sections where animals and trespasses are getting in and rubbish is being thrown over.

It is recommended to install a six-foot chain-link and wooden fence inside the boundary of the allotment to deter animals and trespassers from getting in. Regular maintenance should also be scheduled to ensure ongoing durability. The gate sign to have Bexhill ton council details.
